## KELLS ROUND TOWER: PROGRESS, CHALLENGES AND LESSONS LEARNED

The Board of the Heritage Register, in partnership with the OPW, recently undertook a follow up visit to Kells Round tower to review progress and learn more about the conservation techniques and lessons learned from this important conservation project.

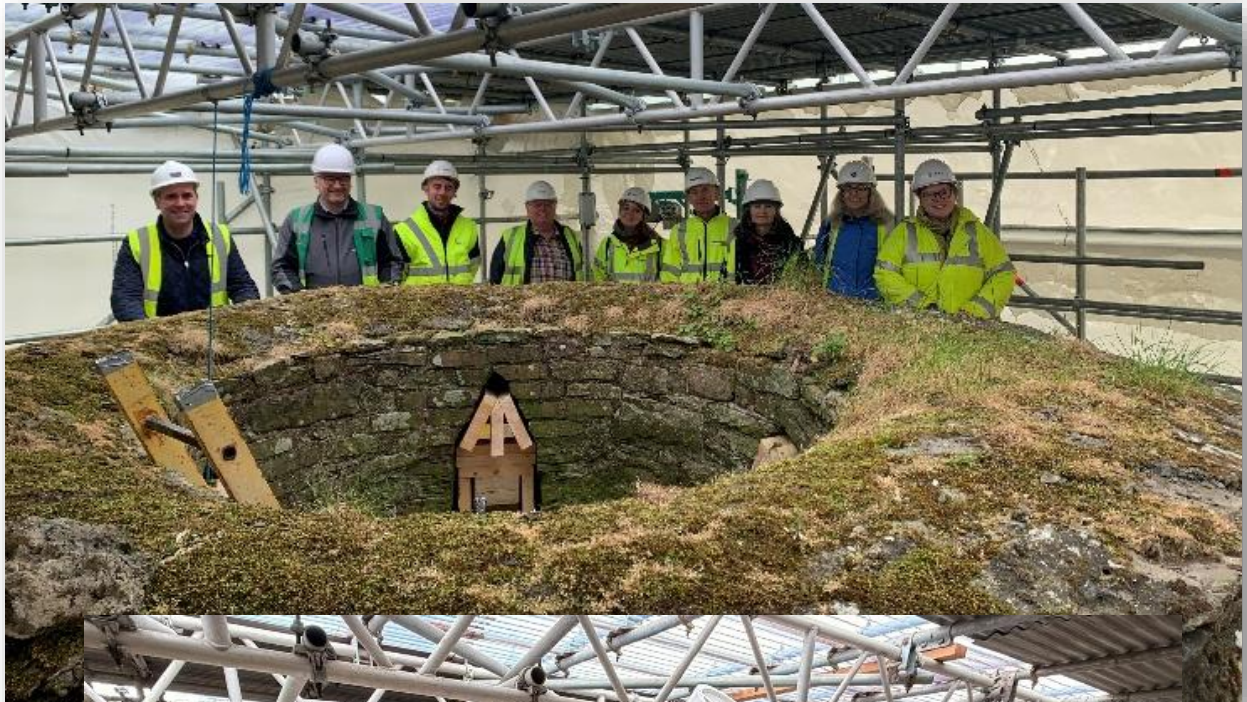
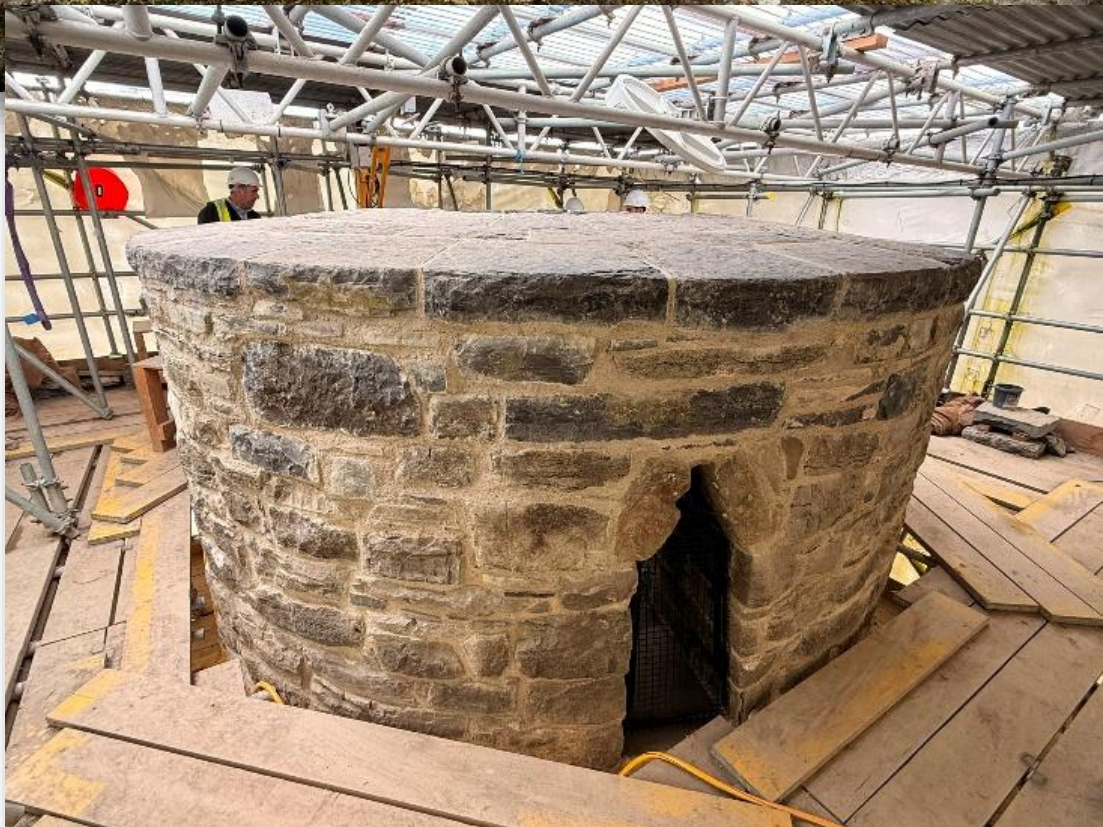
*Before and After Photographs of the Round tower and cut stone capping*

The tower stands approximately 85 feet in height and uncapped. As with many historic structures, evidence of its original appearance has been lost over time. Research undertaken as part of the conservation project has informed proposals for the tower's restoration and will include a conical stone cap similar to other surviving round towers.

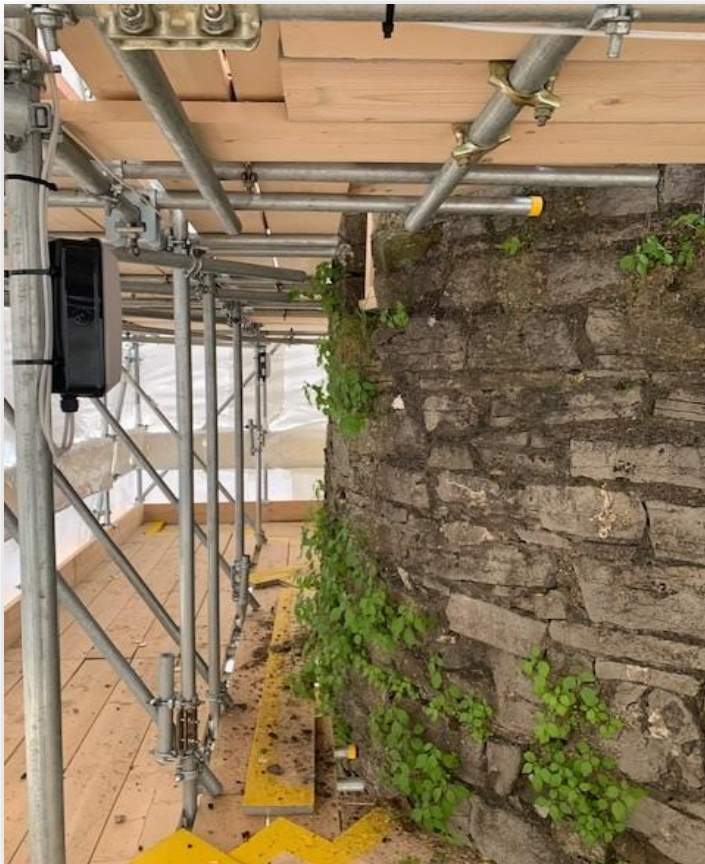
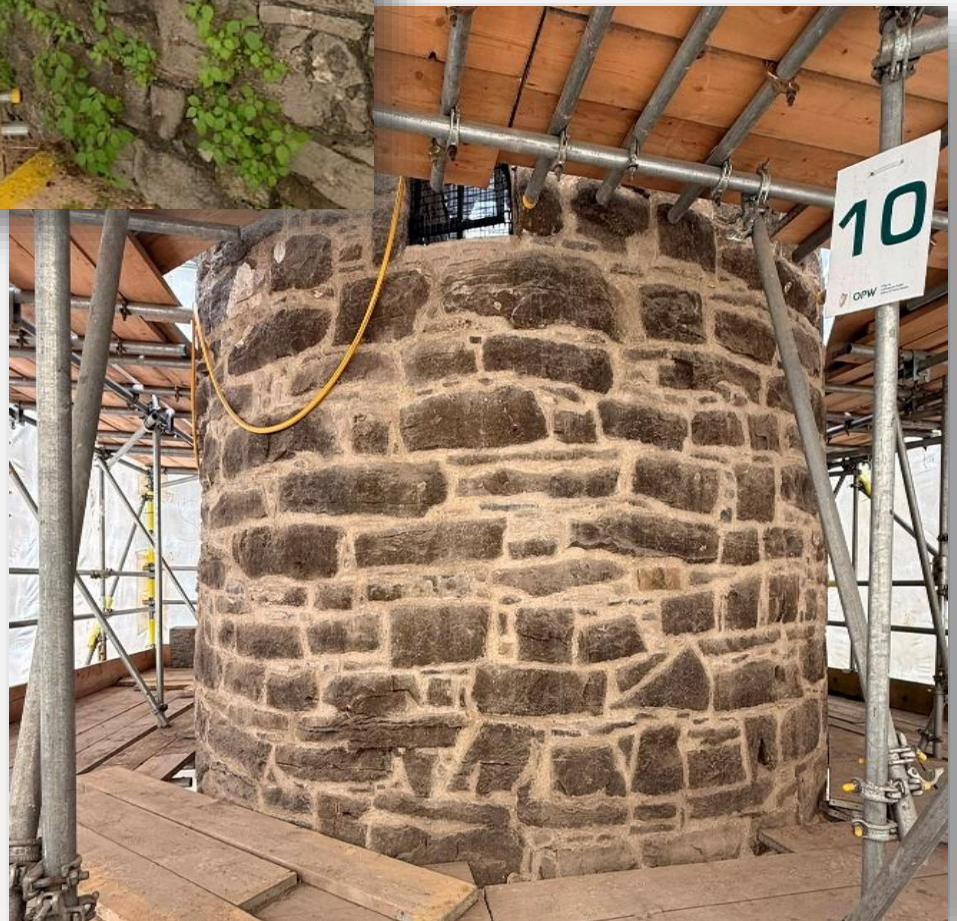
*Before and After Photographs:*

*Vegetation removal and the cleaning and repointing of stonework using appropriate conservation materials.*

Repairs to the mural tower included removal of vegetation, sourcing aggregates similar to the original and repointing the stonework.
